**Flood Control Project Maintenance
Levee Inspections**

Fall 2018 Levee Maintenance Deficiency Summary Report

Sutter Maintenance Yard Hamilton Bend

Waterway	Bank	Unit Miles	Inspection Start/End	Inspector
Unit No. 01 Feather River Hamilton Bend	Right	3.39	09/06/2018 09/06/2018	Sterling York

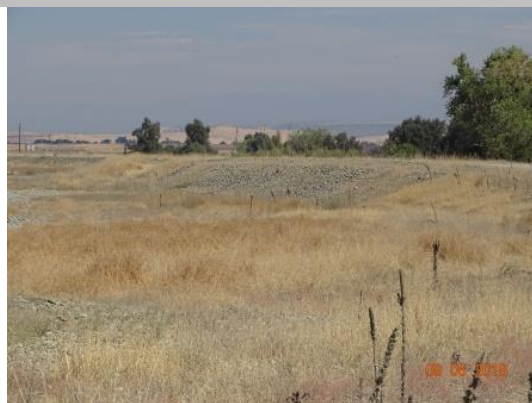
Photo 1 of 1 : FA_2018_ST0005_289_3_20181003_00015.jpg

LM Start	0.02	Rating **	A	Issue No.	3
LM End	1.21	Issue Type +	Ma	Location *	LS
Category	Earthen Levee			GPS Latitude/Longitude	
				Start	End
Item	Vegetation			39.439960 °	39.456723 °
				-121.641439 °	-121.639323 °
DWR ID	DWR_ST0005_01_f_2018_3				
Comment Code					
V1 : Control annual grass and weeds on the levee slopes and easements.					
Inspector Comment					
Maintained annual vegetation, this section is sprayed but not mowed due to the cobbles, Fall 2018.

View looking upstream landside of the maintained annual vegetation, this section is sprayed but not mowed due to the cobbles, Fall 2018.

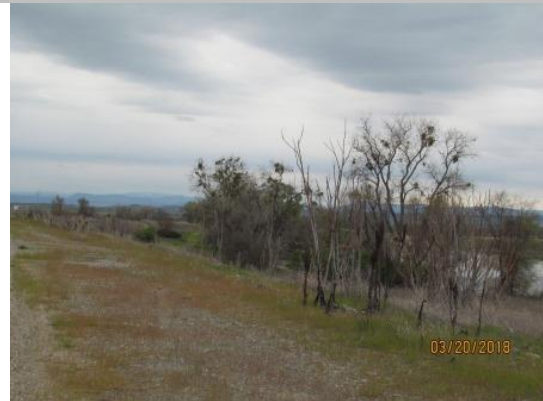
Photo 1 of 1 : FA_2018_ST0005_289_14_20180918_00005.jpg

LM Start	0.73	Rating **	A/W	Issue No.	14
LM End	0.91	Issue Type +	Ma	Location *	WS
Category	Earthen Levee			GPS Latitude/Longitude	
				Start	End
Item	Trim / Thin Trees			39.450109 °	39.452643 °
				-121.640851 °	-121.640316 °
DWR ID	DWR_ST0005_01_s_2016_14				
Comment Code					
T3 : Trim and thin trees to allow visibility of the ground and room to flood fight.					
Inspector Comment					
Small trees 4" in diameter at chest height have been sprayed and should be removed, Fall 2018.

View looking upstream waterside of trees. Small trees 4" in diameter at chest height have been sprayed and should be removed, Spring 2018.

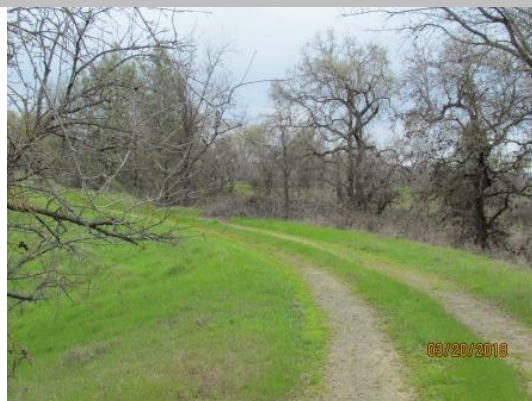
Photo 1 of 1 : FA_2018_ST0005_289_18_20180918_00007.jpg

LM Start	1.48	Rating **	U	Issue No.	18
LM End	1.99	Issue Type +	Ma	Location *	WS
Category	Earthen Levee			GPS Latitude/Longitude	
				Start	End
Item	Trim / Thin Trees			39.458053 °	39.461949 °
				-121.636300 °	-121.629563 °
DWR ID	DWR_ST0005_01_s_2017_18				
Comment Code					
T3 : Trim and thin trees to allow visibility of the ground and room to flood fight.					
Inspector Comment					
From Levee Mile 1.38 to 3.39 has never been maintained by the LMA.

View looking upstream of thick trees and vegetation blocking visibility on waterside, looking downstream. Spring 2018.

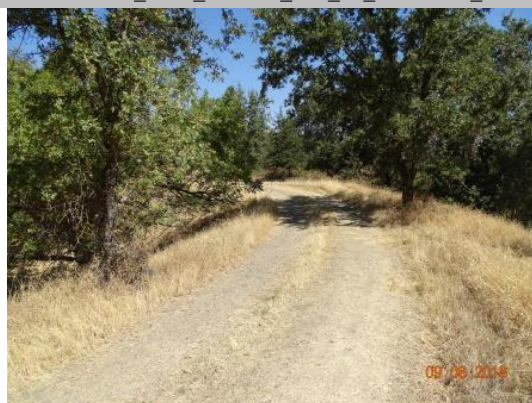
Photo 1 of 1 : FA_2018_ST0005_289_11_20181003_00014.jpg

LM Start	1.48	Rating **	U	Issue No.	11
LM End	3.25	Issue Type +	Ma	Location *	LS
Category	Earthen Levee			GPS Latitude/Longitude	
				Start	End
Item	Trim / Thin Trees			39.458055 °	39.470312 °
				-121.636300 °	-121.609242 °
DWR ID	DWR_ST0005_01_s_2017_11				
Comment Code					
T3 : Trim and thin trees to allow visibility of the ground and room to flood fight.					
Inspector Comment					
From Levee Mile 1.38 to 3.39 has never been maintained by the LMA.

View looking upstream landside and waterside of thick trees blocking visibility on landside, Fall 2018.

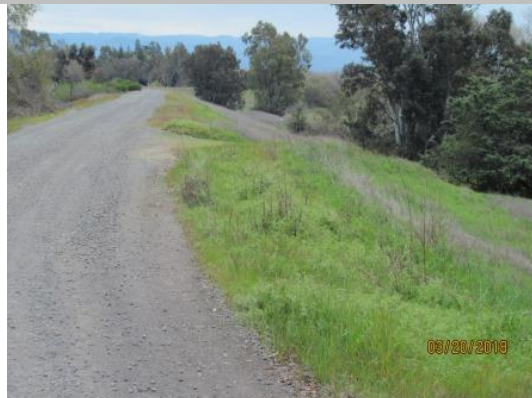
Photo 1 of 1 : FA_2018_ST0005_289_17_20180918_00006.jpg

LM Start	1.50	Rating **	M	Issue No.	17
LM End	1.96	Issue Type +	Ma	Location *	WS
Category	Earthen Levee			GPS Latitude/Longitude	
				Start	End
Item	Vegetation			39.458131°	39.461634°
				-121.635916°	-121.629926°
DWR ID	DWR_ST0005_01_f_2017_17				
Comment Code					
V2 : Remove the wild growth other than native grasses from the levee slopes.					
Inspector Comment					
Maintain annual grasses, Fall 2018.

View looking upstream waterside of annual grasses that need to be maintained, Spring 2018.

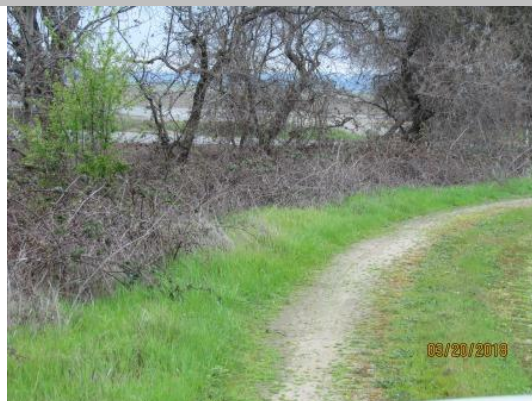
Photo 1 of 1 : FA_2018_ST0005_289_6_20180918_00002.jpg

LM Start	1.50	Rating **	U	Issue No.	6
LM End	2.63	Issue Type +	Ma	Location *	LS
Category	Earthen Levee			GPS Latitude/Longitude	
				Start	End
Item	Vegetation			39.458132 °	39.466025 °
				-121.635914 °	-121.618972 °
DWR ID	DWR_ST0005_01_f_2016_6				
Comment Code					
V2 : Remove the wild growth other than native grasses from the levee slopes.					
Inspector Comment					
Blackberries covering slope. From Levee Mile 1.38 to 3.39. This section has never been maintained by the LMA.

View looking upstream landside of blackberries that are covering the landside slope, Spring 2018.

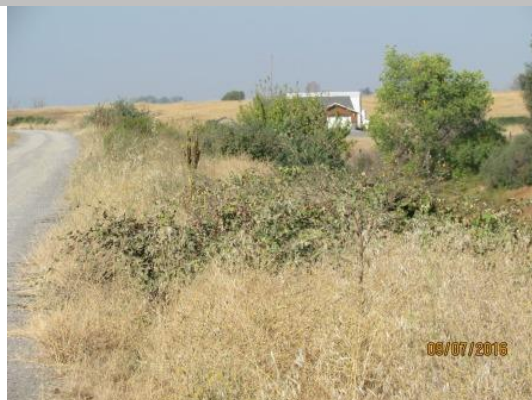
Photo 1 of 1 : FA_2018_ST0005_289_10_20180918_00003.jpg

LM Start	2.46	Rating **	M	Issue No.	10
LM End	2.48	Issue Type +	Ma	Location *	LS
Category	Earthen Levee			GPS Latitude/Longitude	
				Start	End
Item	Vegetation			39.465370 °	39.465410 °
				-121.622074 °	-121.621736 °
DWR ID	DWR_ST0005_01_f_2016_10				
Comment Code					
V2 : Remove the wild growth other than native grasses from the levee slopes.					
Inspector Comment					
Blackberry bushes are covering landside slope. From Levee Mile 1.38 to 3.39 has never been maintained by the LMA.

View of blackberries that are covering landside slope.

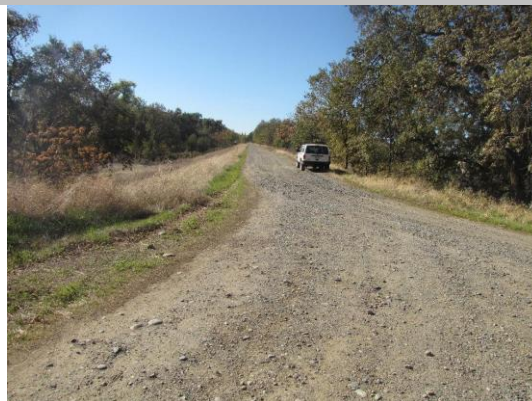
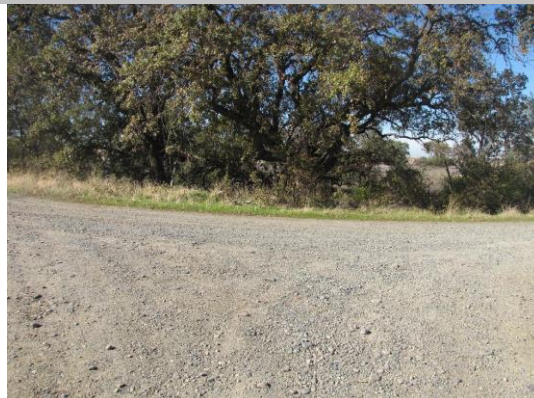
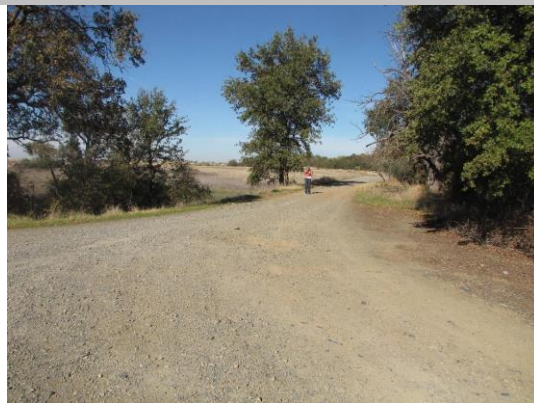
Comment Code						
Inspector Comment						
FS_ID:47972						
DS_ID:17044						
EP_NO: N/A						
Repair Type: Non-Urgent						
Crossing Status: Indicator Found						
UCIP Comments: 4/26/2016 Unable to access area near						
structure.5/14/2013 Same as last inspection.11/14/2012						
Abandoned Structure: WS- reminisce of gates and concrete standpipe;						
LS-reminisce of concrete headwall and pump station.						
FIELD_STRUCT_DESC: *ABANDONED* [Western Canal Head Gate						
Inlet Structure] 1 of 2: 96-inch by 96-inch (8-foot by 8-foot) reinforced						
concrete culverts through the levee 25 feet below the crown. Three slide						
gates on the waterside (WS) end. Concrete stairs on the WS slope.						
Concrete headwall at both WS and landside (LS) toes. [Additional						
Reference(s): DWR Levee Log, 2005. USACE Sacramento O&M						
Manual 152, March 1957 (Station 170+00)]						
FS Date: 5/3/2016 12:36:00 PM

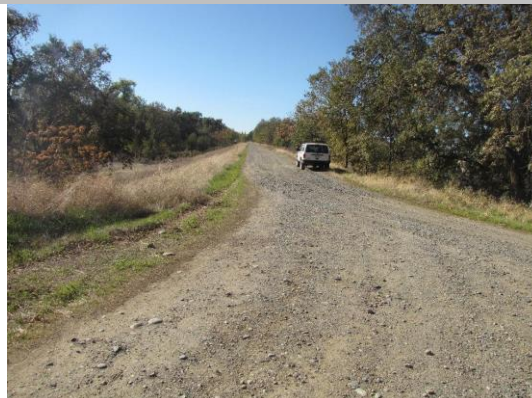
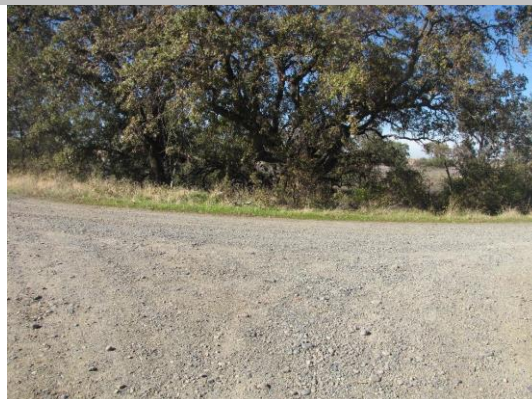
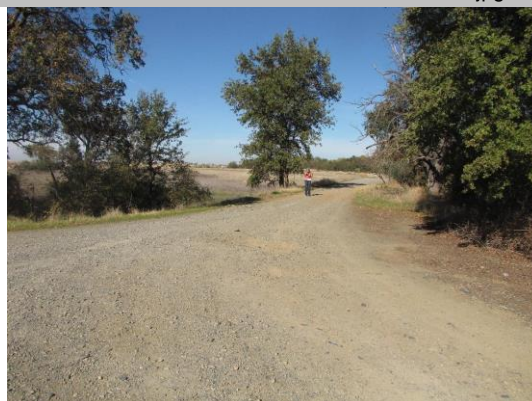
Comment Code						
Inspector Comment						
FS_ID:47973 DS_ID:17056 EP_NO: N/A Repair Type: Non-Urgent Crossing Status: Indicator Found UCIP Comments: 4/26/2016 Unable to access area near structure.5/14/2013 Same as last inspection.11/14/2012 Abandoned Structure: WS- reminince of gates and concrete standpipe; LS-reminince of concrete headwall and pump station. FIELD_STRUCT_DESC: *ABANDONED* [Western Canal Head Gate Inlet Structure] 2 of 2: 72-inch by 96-inch (8-foot by 8-foot) reinforced concrete culvert through the levee 25 feet below the crown. Three slide gates on the waterside (WS) end. Concrete stairs on the WS slope. Concrete headwall at both toes. [Additional Reference(s): DWR Levee Log, 2005. USACE Sacramento O&M Manual 152, March 1957 (Station 170+00)] FS Date: 5/3/2016 12:37:00 PM
